# Causeway Coast & Glens Borough Council

HARBOUR AND MARINE ENVIRONMENTAL IMPROVEMENTS  
NORTH PIER PORTRUSH

1<sup>st</sup> September 2015

Report to Committee

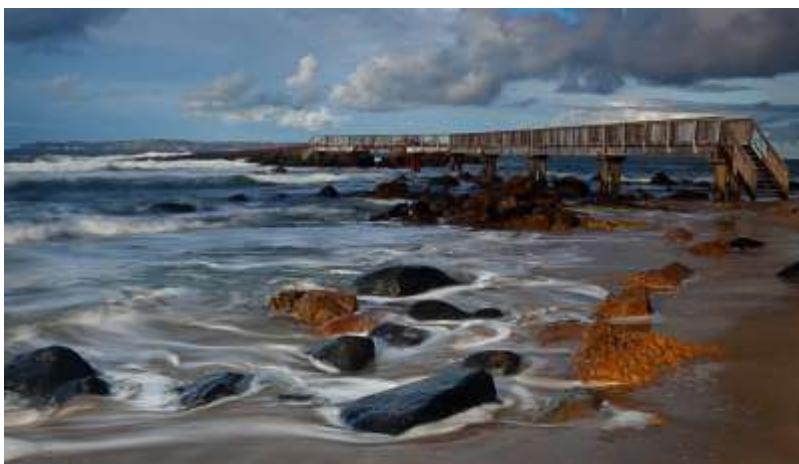
The Pan's Rock is a rock formation at the eastern end of Ballycastle Beach, being the remains of an Iron Salt pan. The seven span footbridge facilitates access onto the rock as it becomes an island at high tide.

During the time of this condition survey, the strong winds and tide in December 2014 completely washed away the beachside access steps and foundation. This area of failure has been cordoned off to prevent access until the completion of the report.

Option 1: Carry out minimum repairs to facilitate a low cost and prompt re-opening. Note this only provides a short term repair solution, approximately 10 years.

It is recommended the Environmental Services Committee approve the progression of Option 1 to Stage 2 of the Procurement Process.

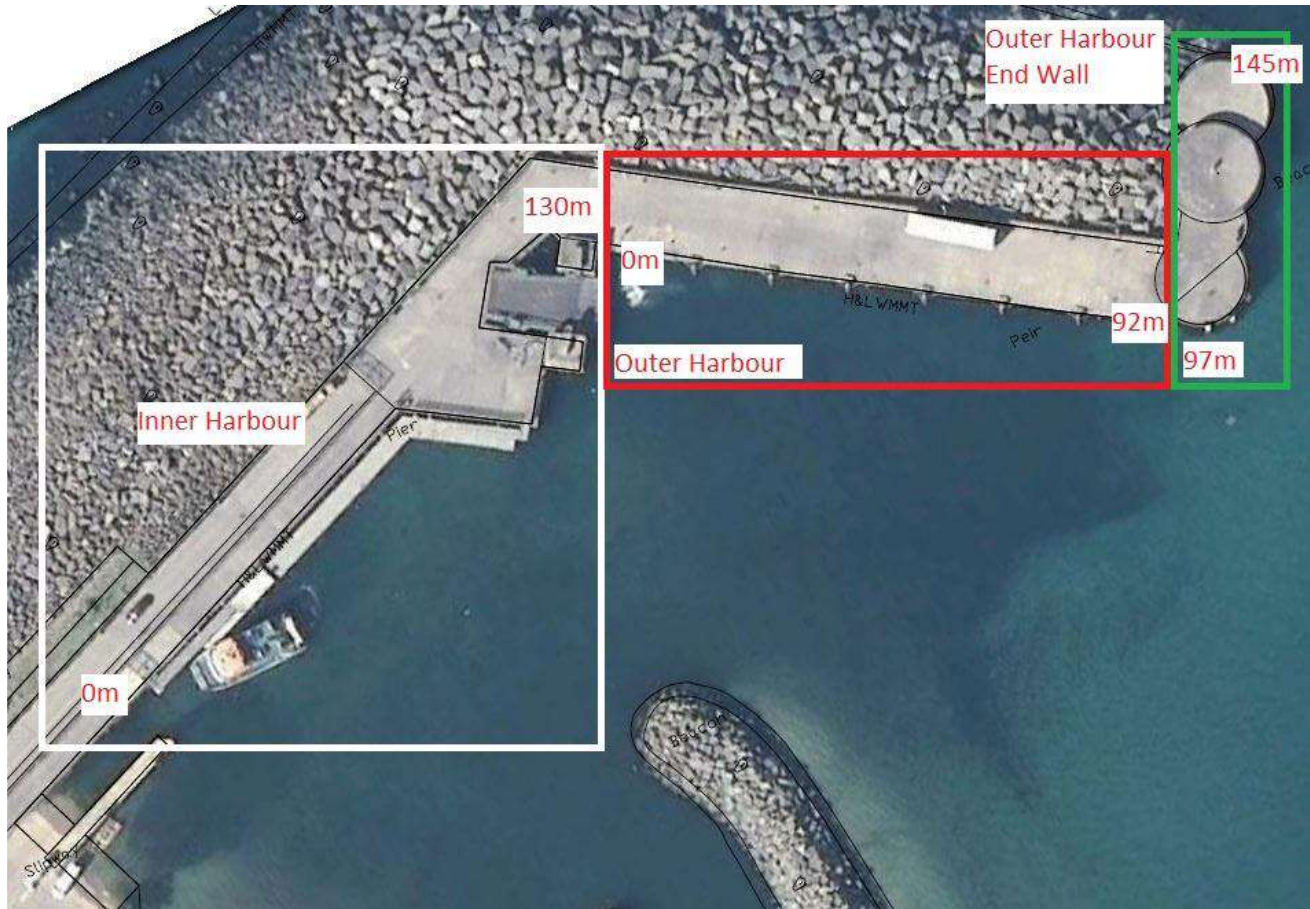
The structures have been in place for more than 15 years, and in addition the sheet piles were painted during the construction phase as a protection measure to delay corrosion.

The survey has shown that the sheet piles are experiencing high rates of corrosion, in many locations the section loss is greater than the average predicted section loss assuming the most extreme exposure environment despite the limited protection measures implemented (painting).

In summary the majority of the thickness readings taken at both the Inner Harbour and the Outer Harbour cellular caissons showed corrosion levels higher than would be expected for these structures.

The deterioration of the sheet piles should be addressed by the provision of galvanic anodes to provide protection against ongoing corrosion. It is recommended that the anodes be applied to the full extent of the harbour piling to slow down ongoing corrosion and further deterioration particularly in the low water zone (and submerged pile zone).
