<b>HARBOUR ENVIRONMENTAL &amp; STRUCTURE IMPROVEMENT AT NORTH PIER, PORTRUSH HARBOUR</b>	<b>6<sup>th</sup> December 2016</b>
<b>TO: ENVIRONMENTAL SERVICES COMMITTEE</b>	
<b>FOR DECISION</b>

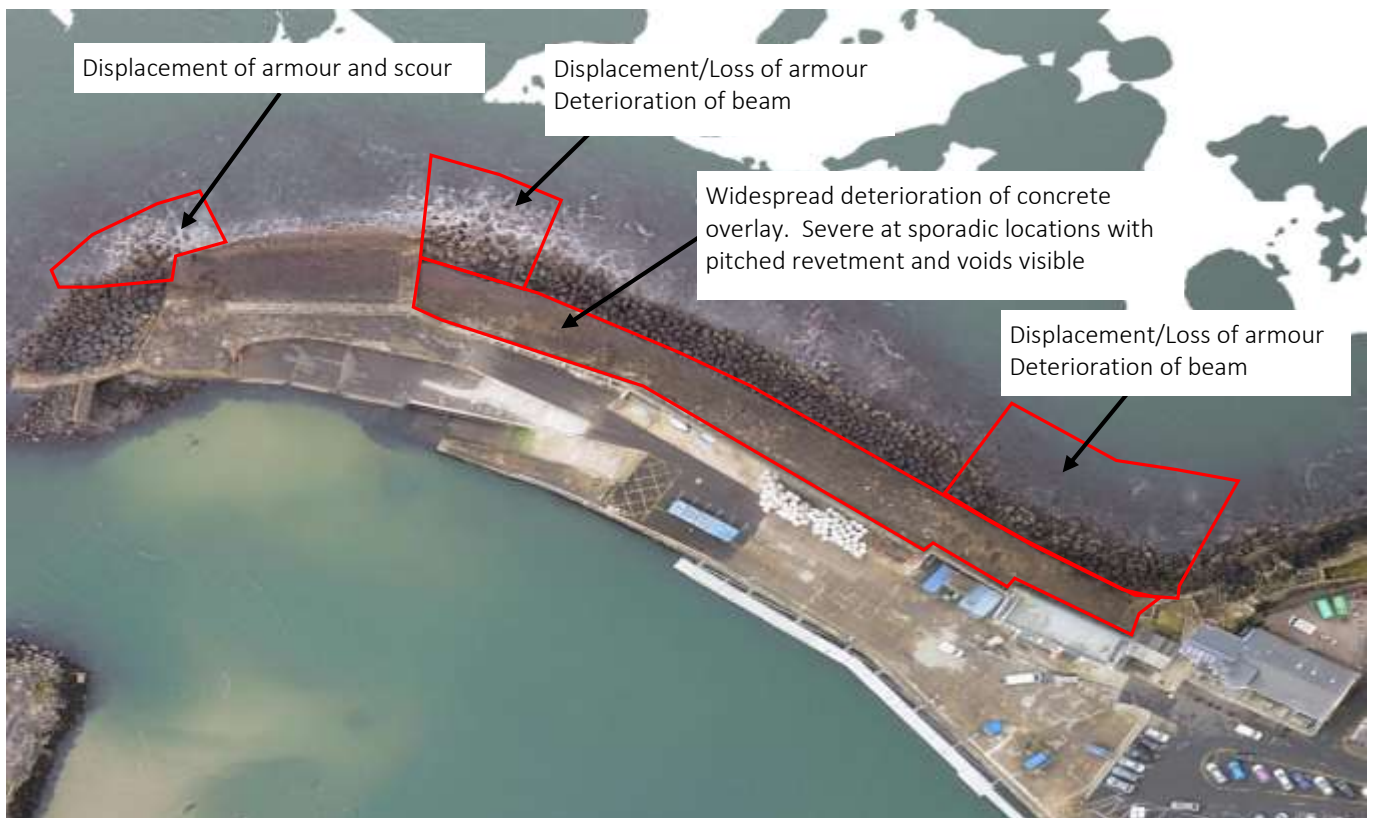
Please see below Diagram 1 in which we detail areas of break water structure deterioration.

- A number of armour stones were noted as having 'split' or broken in-situ.
- Concrete overlay to stone pitched revetment is deteriorating with multiple localised breakdown and loss with exposed voids beneath.
- Loss of rock armour at the root of the structure along various sections, with increased exposure of down stand beam, therefore assisting with continual deterioration of same at this junction.
- Loss of rock armour at the Northern tip of the structure, (main entrance area).

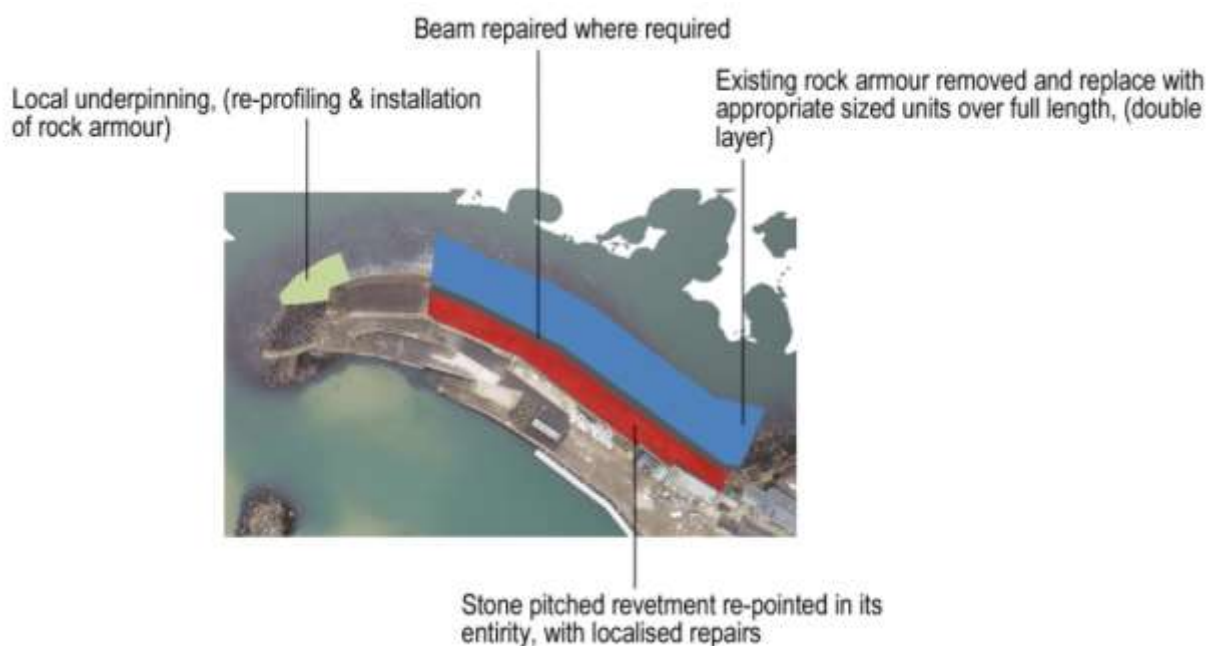
*Diagram 2A below details in general works to be undertaken:-*

- Approx. 10-20% of Rock Armour currently in place will be utilised to raise depressions of under layer or core material and / or fill localised voids identified during the works. Appropriately sized armour, ranging from 8T to 14T with a total of 12, 213T's of rock armour being required, which will provide Council with a 1 in 100 year event coverage.
- Edge beam, (section supporting pitched revetment area at intersection point with rock armour), will be repaired in localised positions where defective.
- Concrete sloping revetment will be replaced, with re-pointing to stone pitched area and isolated repairs carried out.
- Localised underpinning and repair works will be undertaken at the North West, (main harbour entrance area), of the structure.

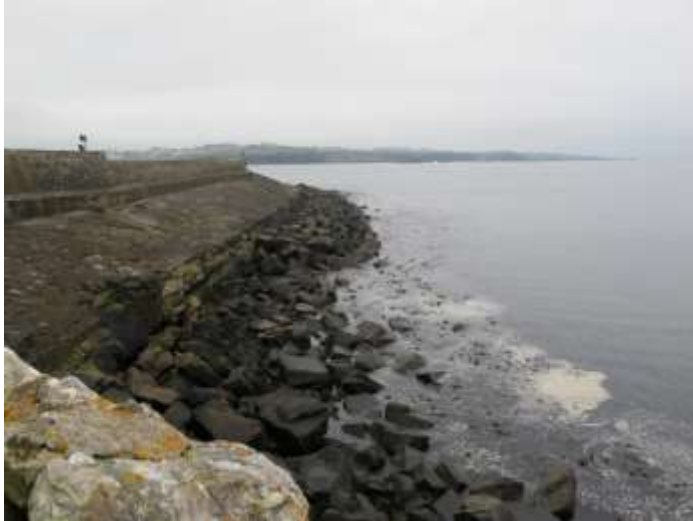
**Image 1.1** – Typical view of breakwater and pitched revetment from the root of the structure

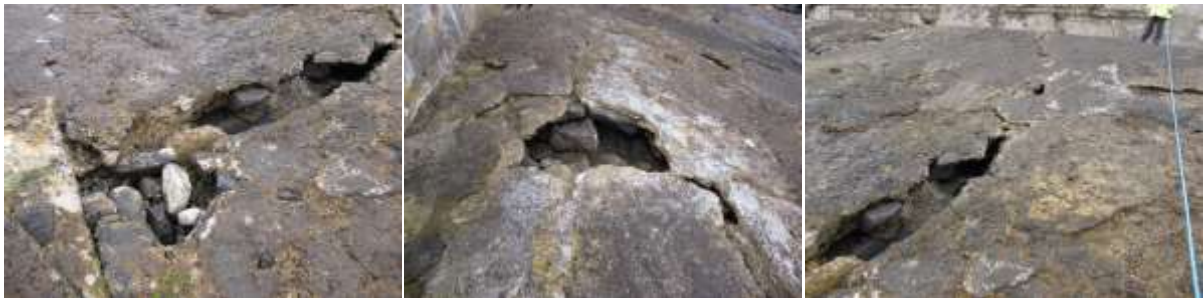
**Image 1.2** – Deterioration of concrete overlay to stone pitched revetment, (multiple locations)

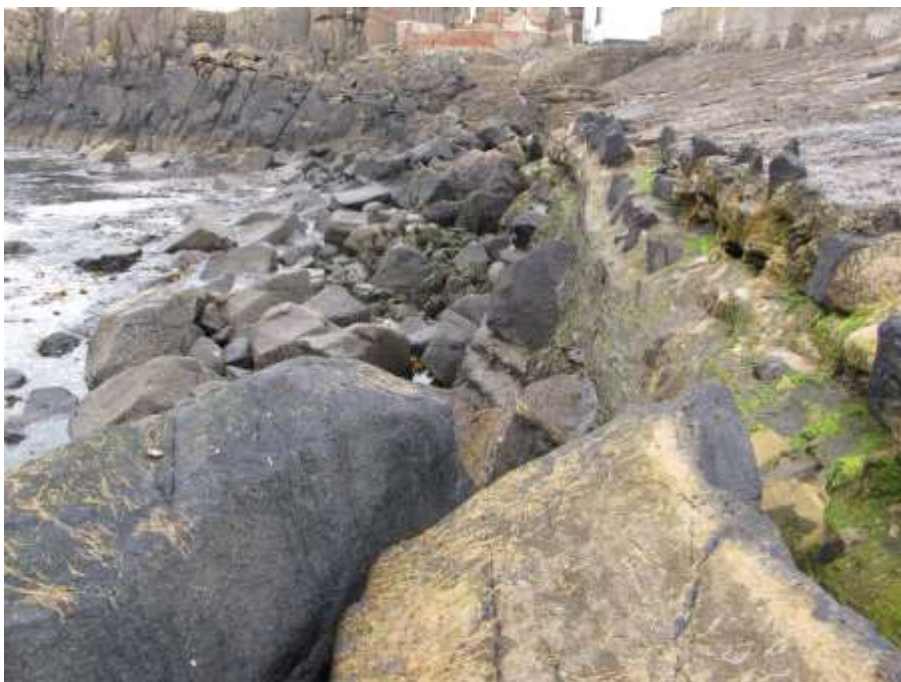
**Image 1.3** – Loss of rock armour at root of the structure and exposed down stand beam

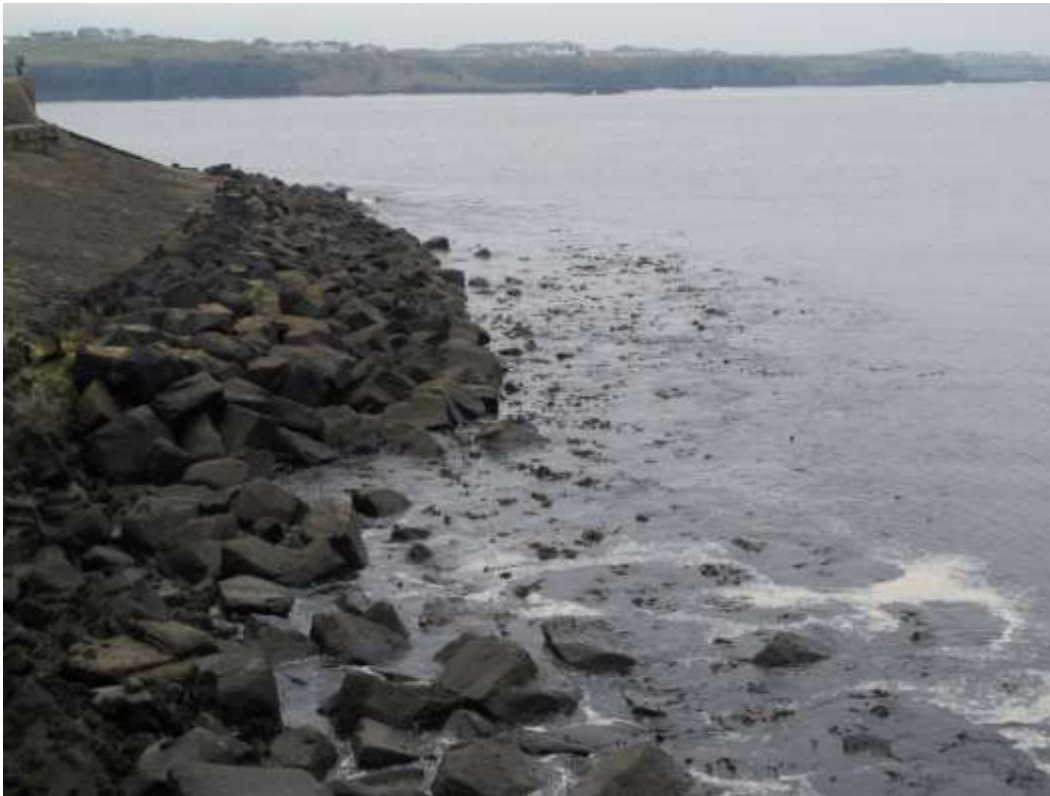
**Image 1.4** – Loss of rock armour adjacent to sloping revetment

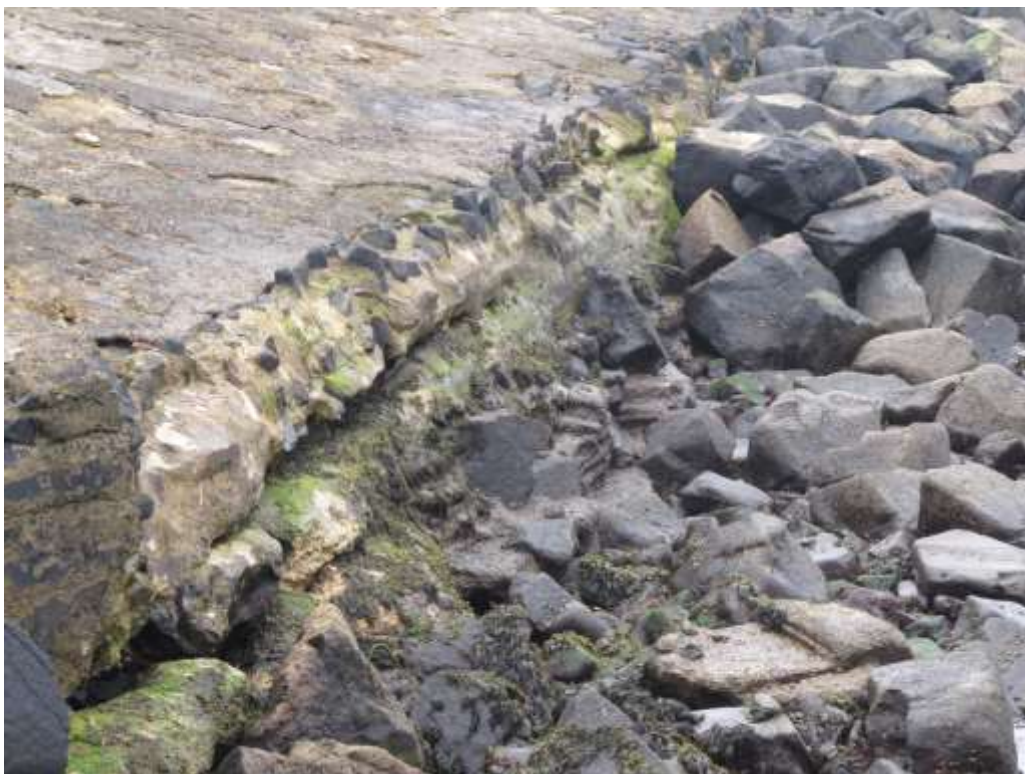
**Image 1.5** – Deterioration of exposed down stand beam at root of structure

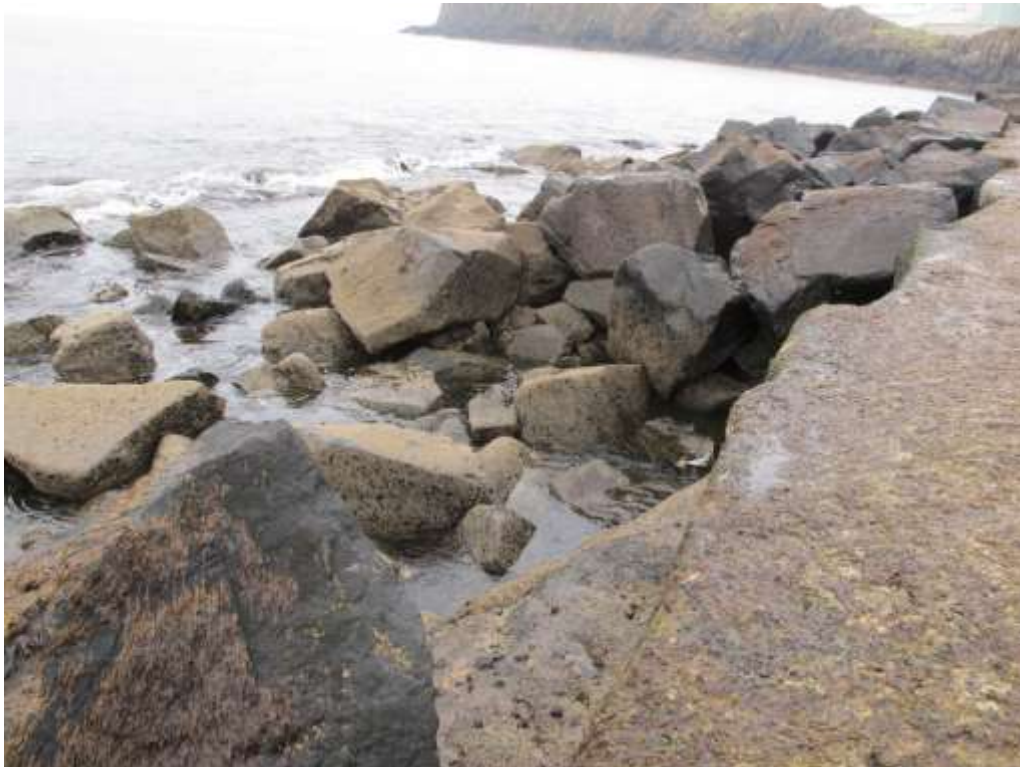
**Image 1.6 – Variation of Rock Armour Size / Mass**

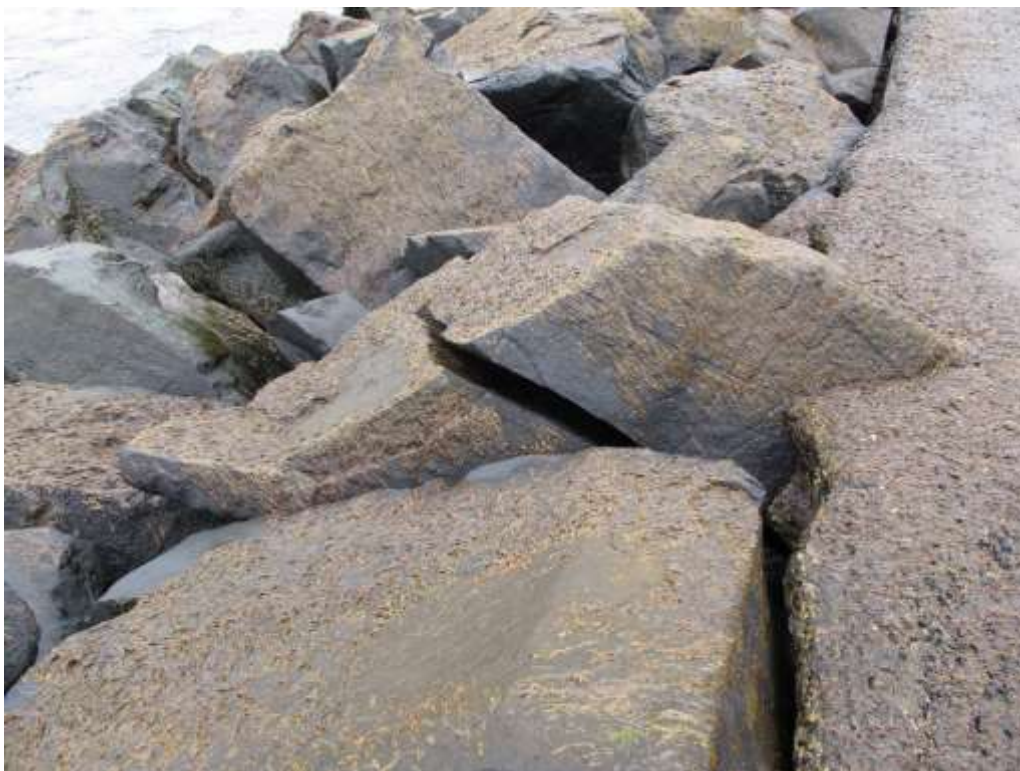
**Image 1.7 – Split in rock armour**
